Walk Around

Fw 190D

By E. Brown Ryle and Malcolm Laing

Focke-Wulf Fw 190D-9

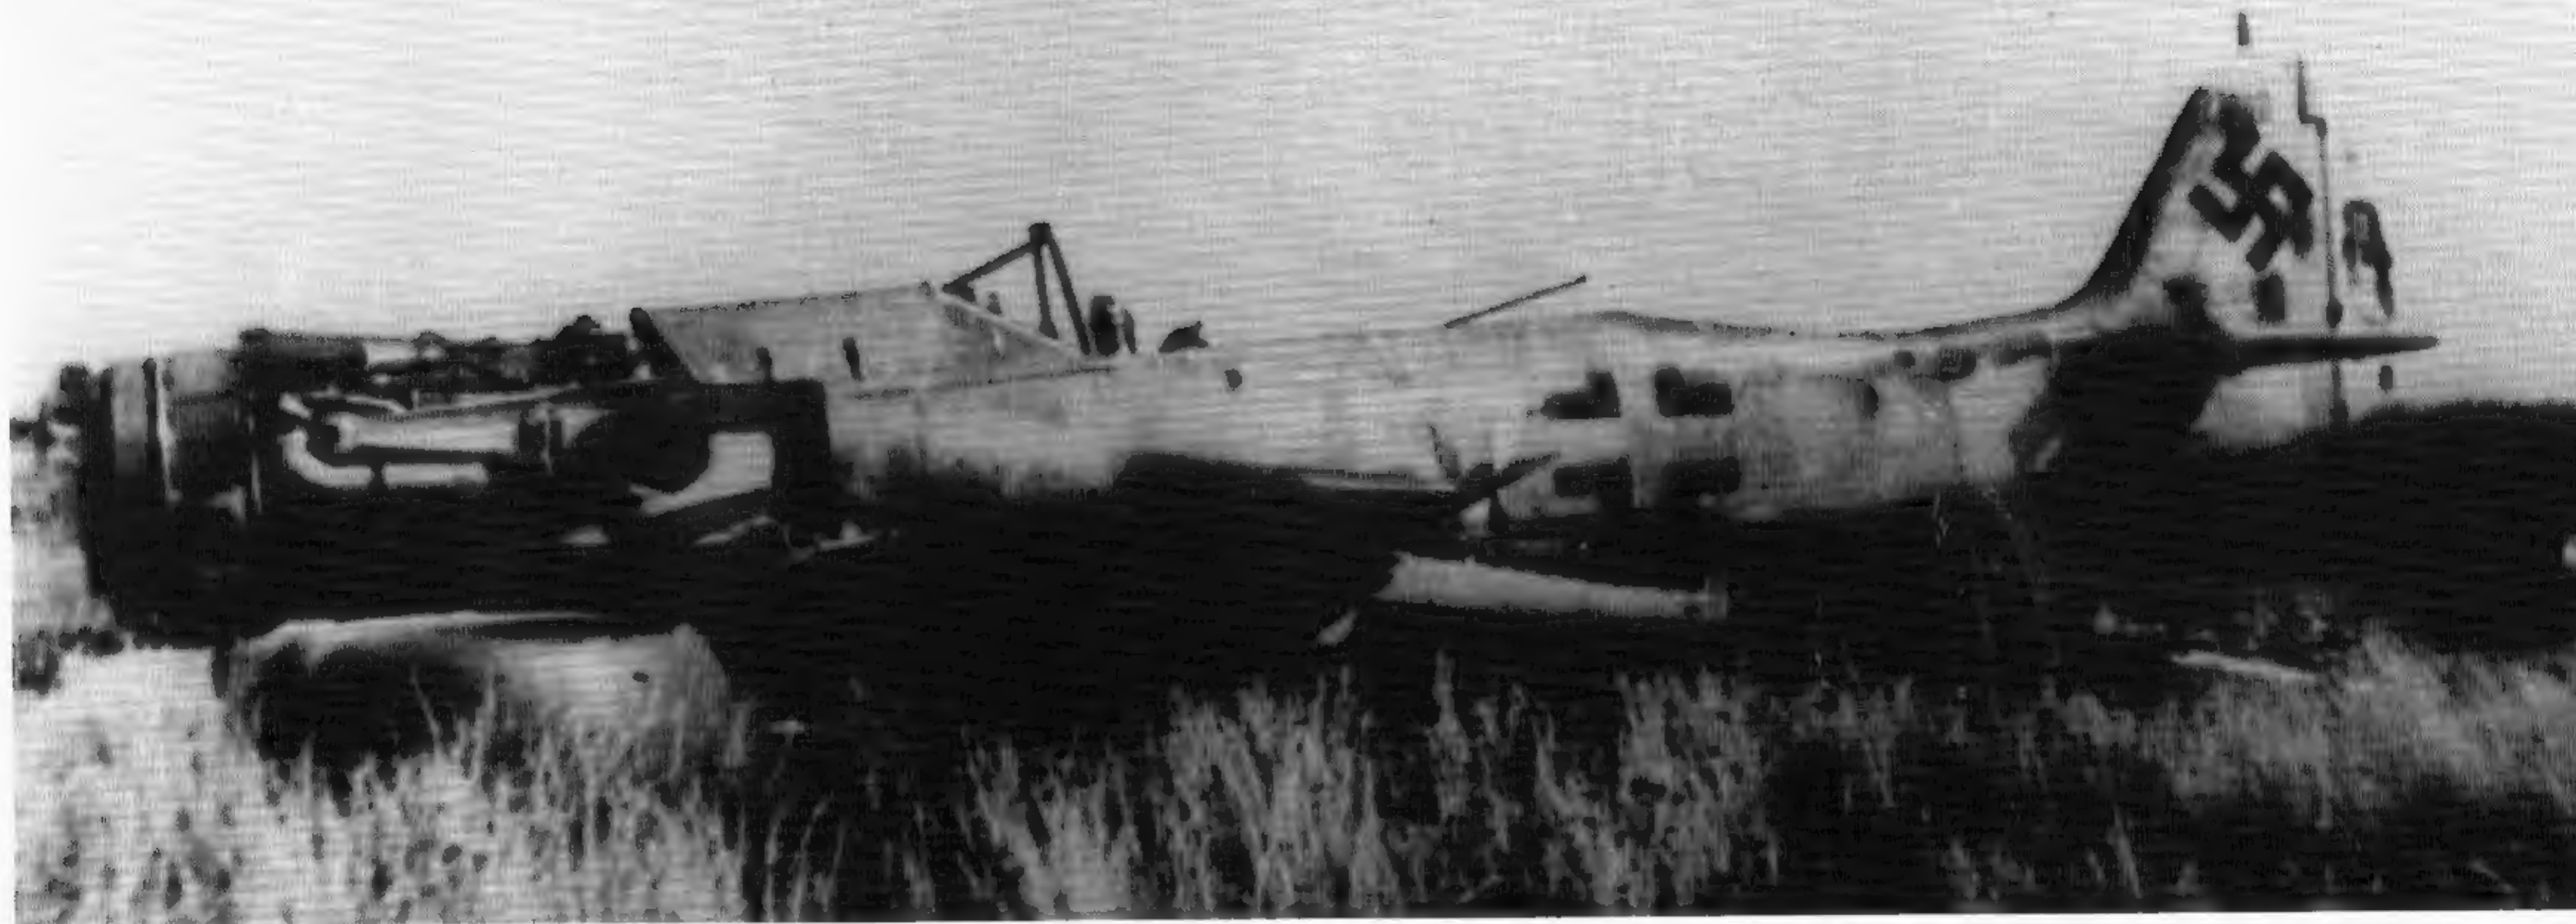
Ending up like most German aircraft during the spring and summer of 1945 — being stripped by souvenir hunters, White < 57 (W.Nr. 220011), an Fw 190D-11 is believed to have been originally assigned to the Stab General der Jagdflieger then assigned to the

Würger Staffel of JV 44. Photographed during the summer of 1945 at Bad Worishofen, Germany. (Petrick via Wadman)

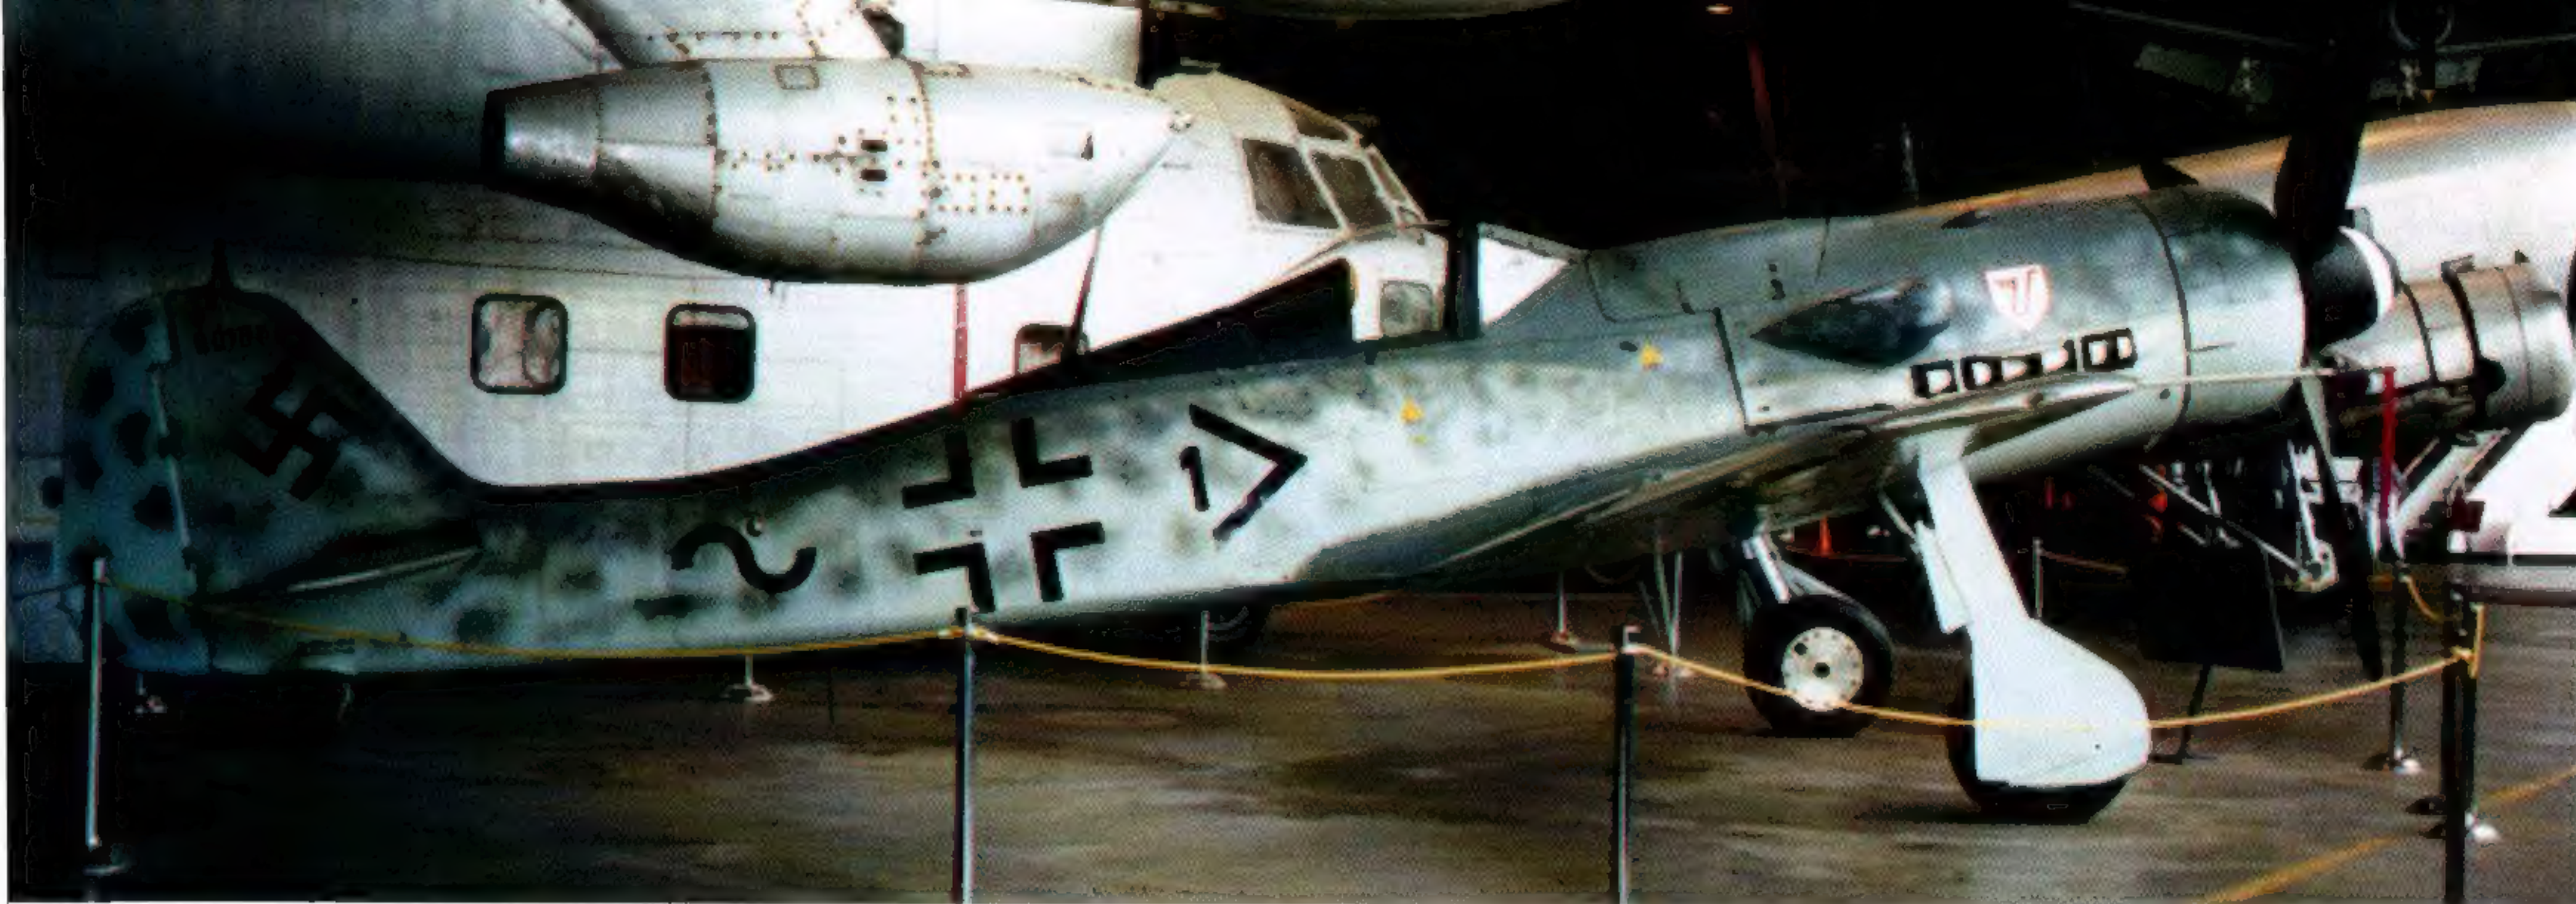
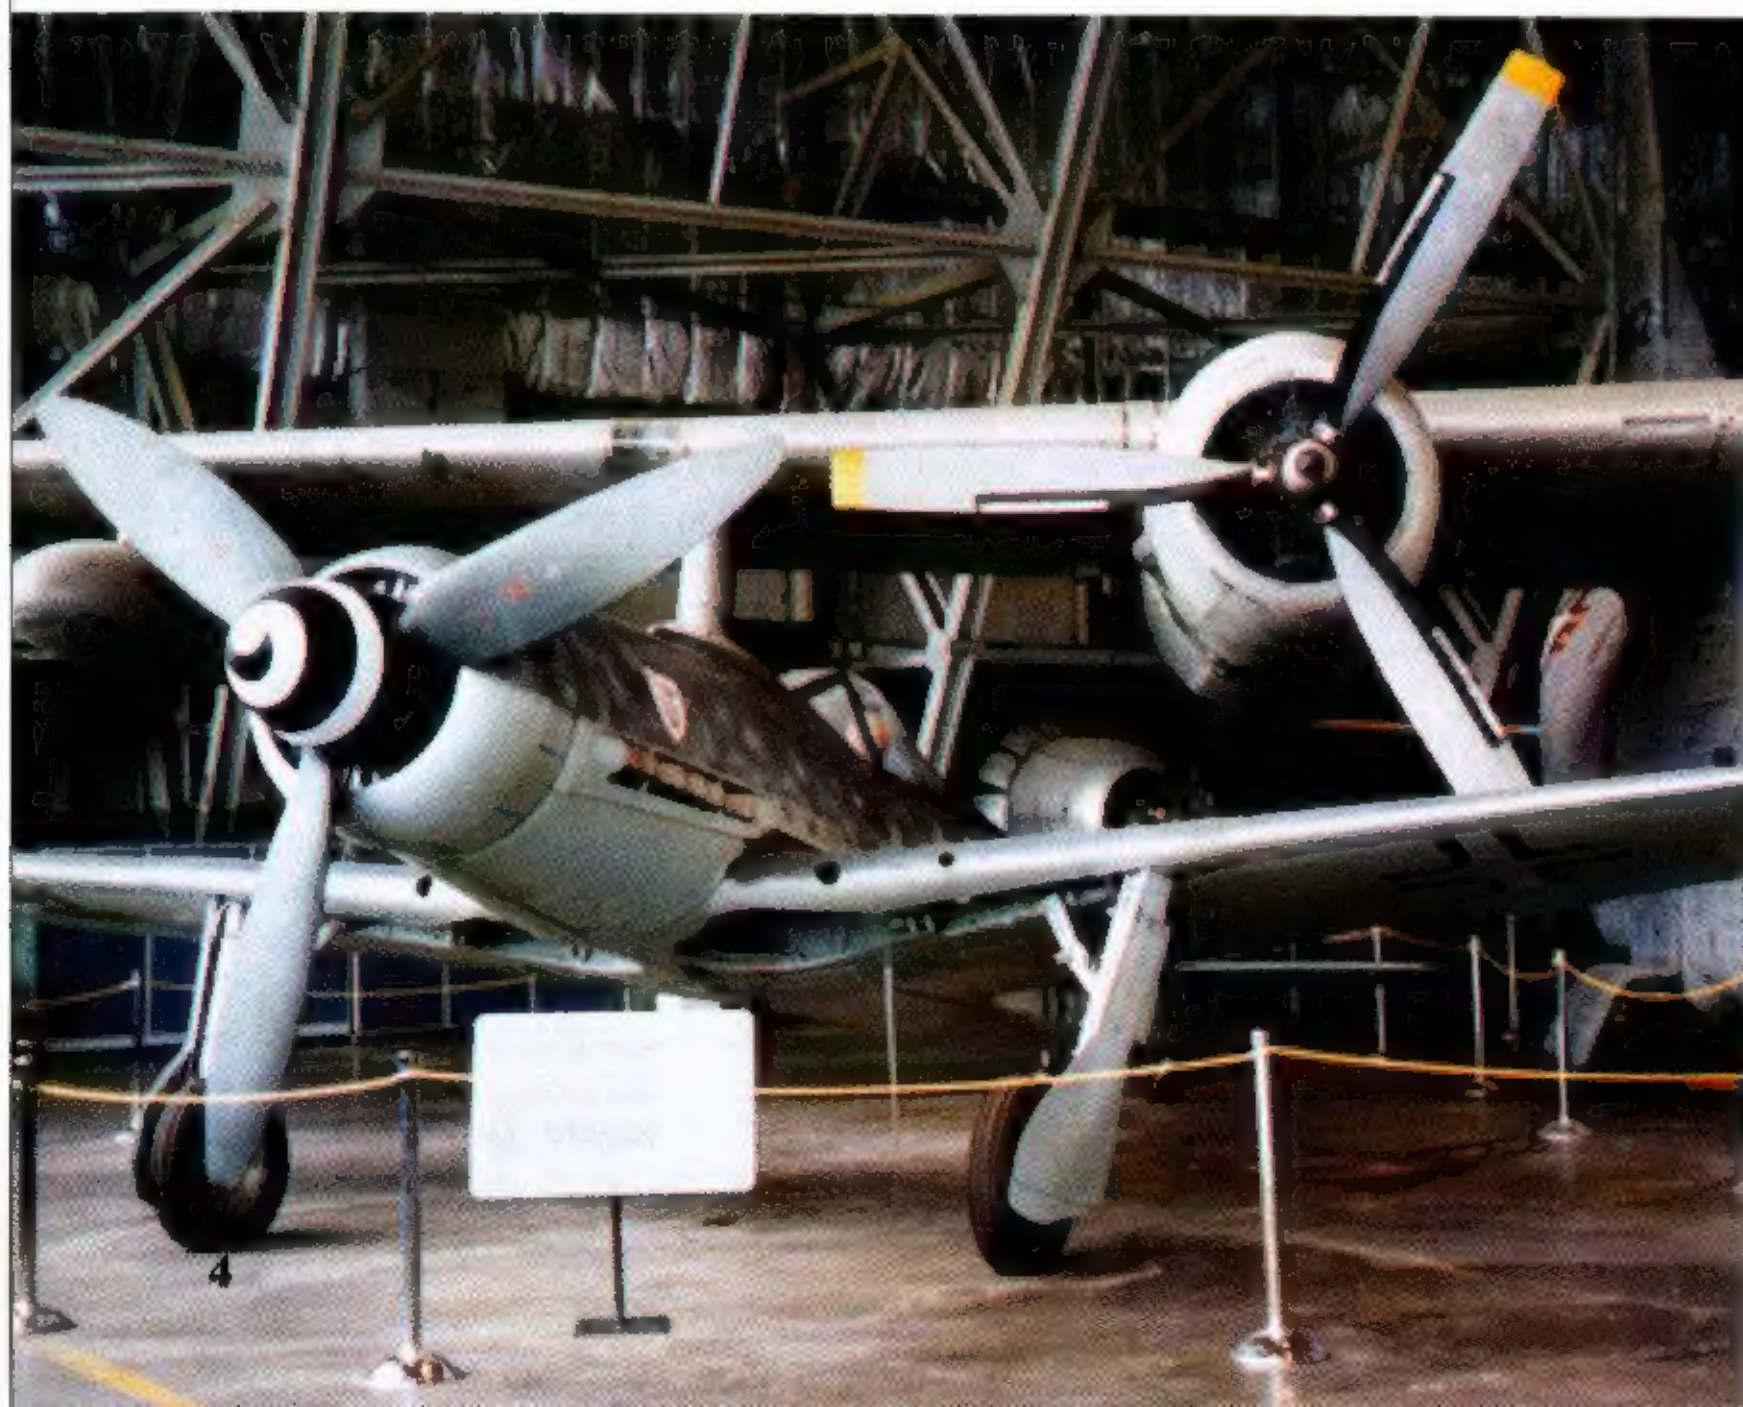
The Fw 190D-9 on display at the USAF Museum at Wright-Patterson AFB, Ohio. It is believed that this aircraft was used operationally by JG 26 and was surrendered to the RAF at Flensburg, then listed as either "USA-12" or "USA-15" when it made its way to the United States aboard HMS Reaper. This may be the Fw 190D-9 which flew six hours of test flights at Wright Field in 1946. The aircraft is now owned by the National Air and Space Museum and is on loan to the USAF Museum in Dayton. The paint scheme was for an aircraft flown by the technical officer of IIWJG 3 'UDET'. (Author: Ryle)

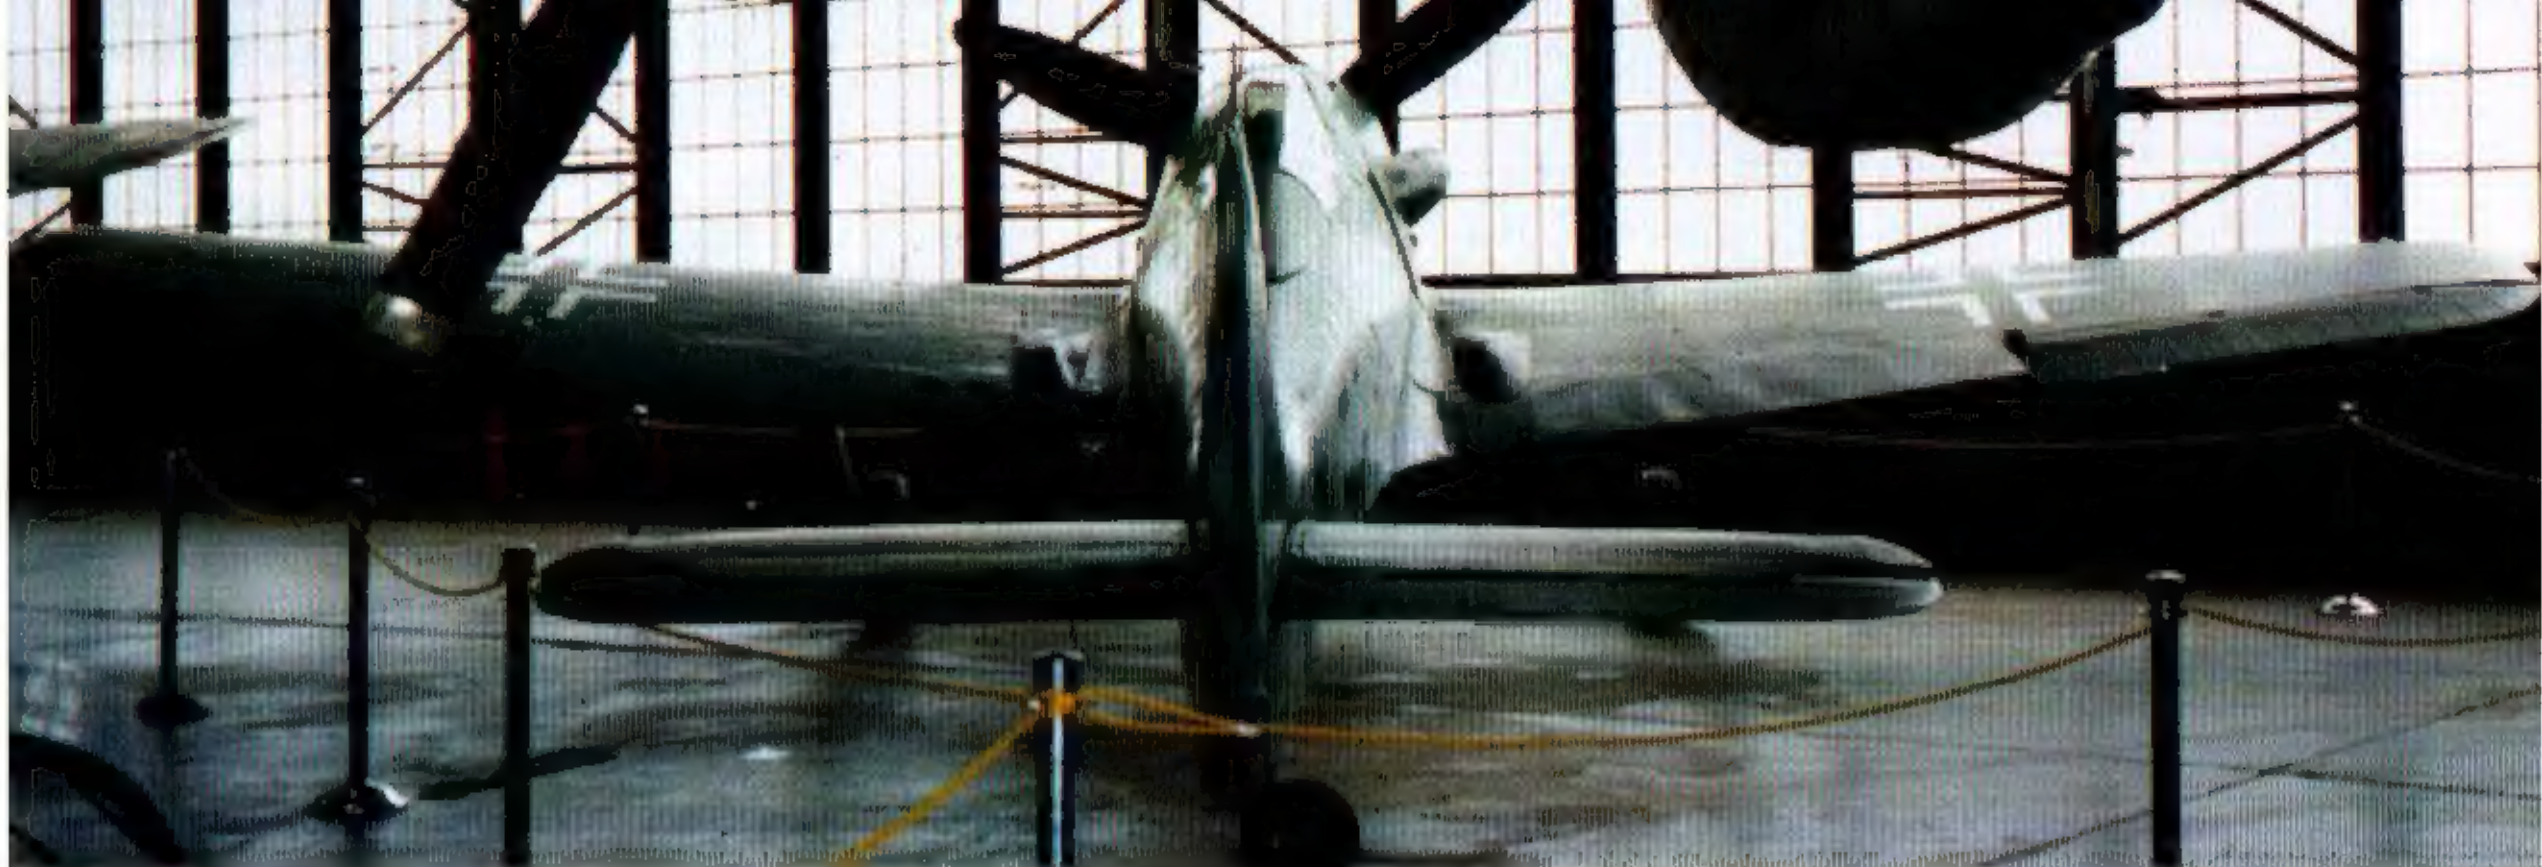
The Fw 190D-9 from the rear, the preferred view of Allied pilots. The taper from the thick forward fuselage to the thin tail assembly is evident. The tail wheel is turned 90 degrees to the right. (L & J Wahsum)

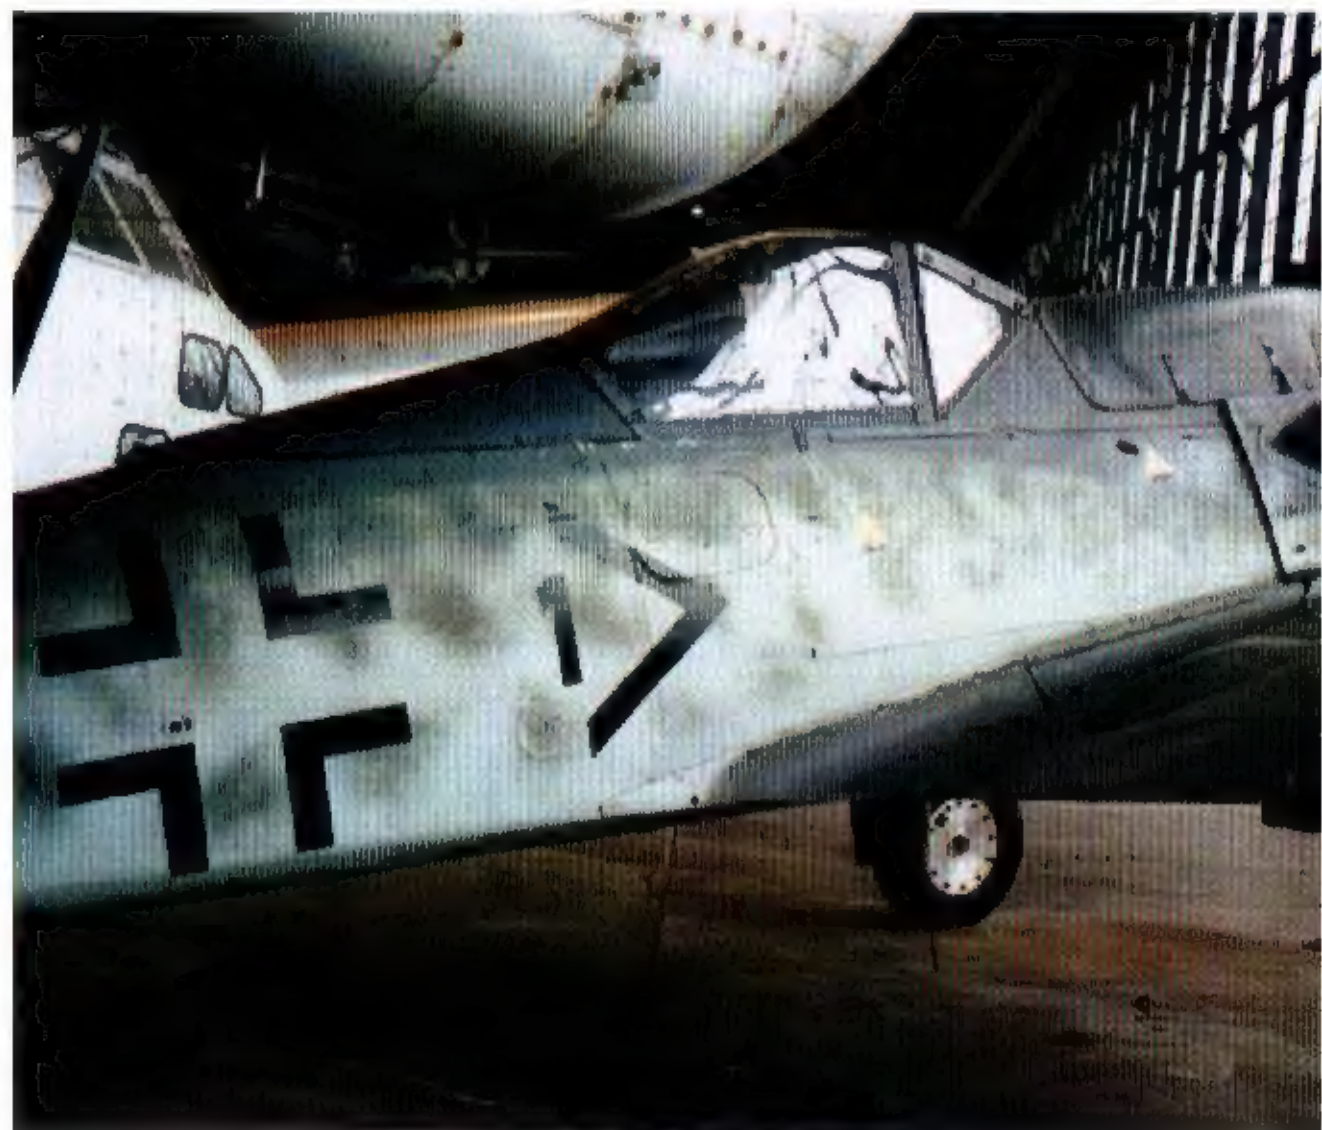
(Above) The USAF Museum's Fw 190D-9 under restoration. The wheels have been removed and the aircraft is on support stands with the lower engine panels removed and the side engine panels open. On the leading edge of the wing, at the landing gear connection point, the outboard 'cannon' panel has been removed. (USAF Museum via Tullis)

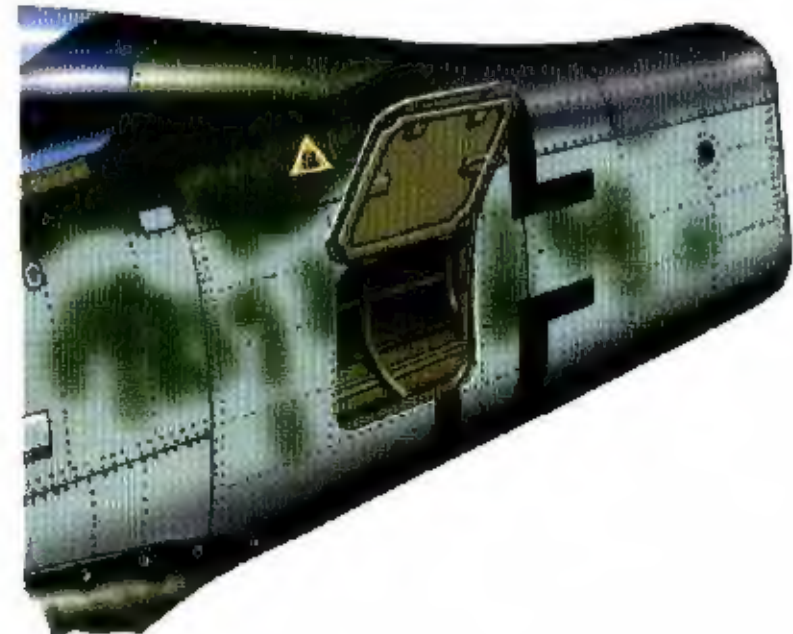
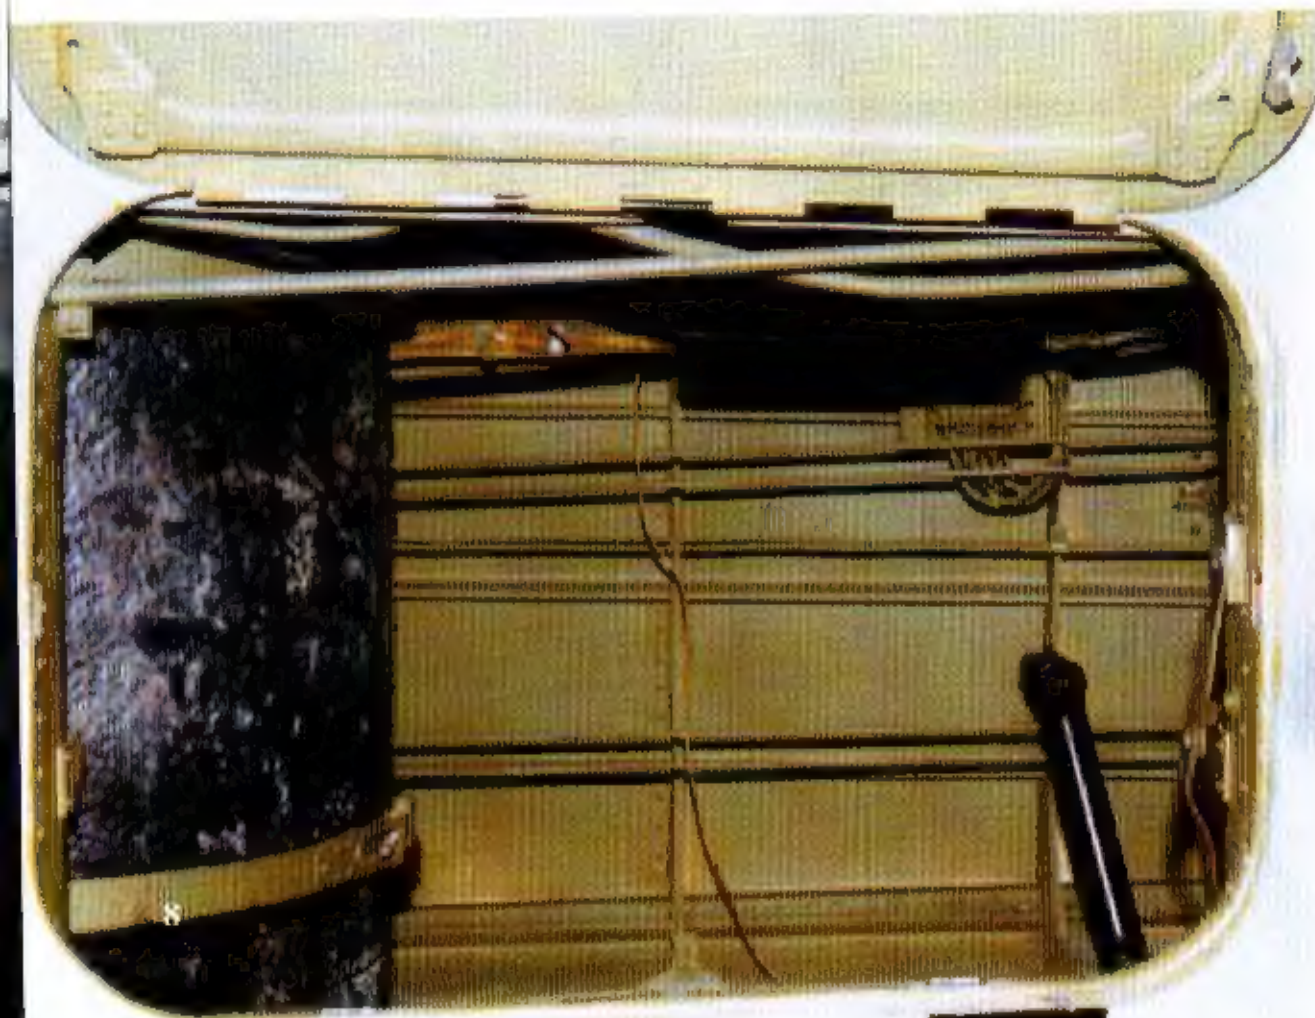
Fuselage Access Door

On the port side of fuselage is the aft fuselage access door. This door is original and has the correct four latches. (Author: Ryle)

Looking straight into the fuselage access opening, the auxiliary fuel tank (left) and the starter crank (right) readily stand out. On the opposite side of the fuselage the elevator control cables run along the side of the fuselage. (Author: Ryle)

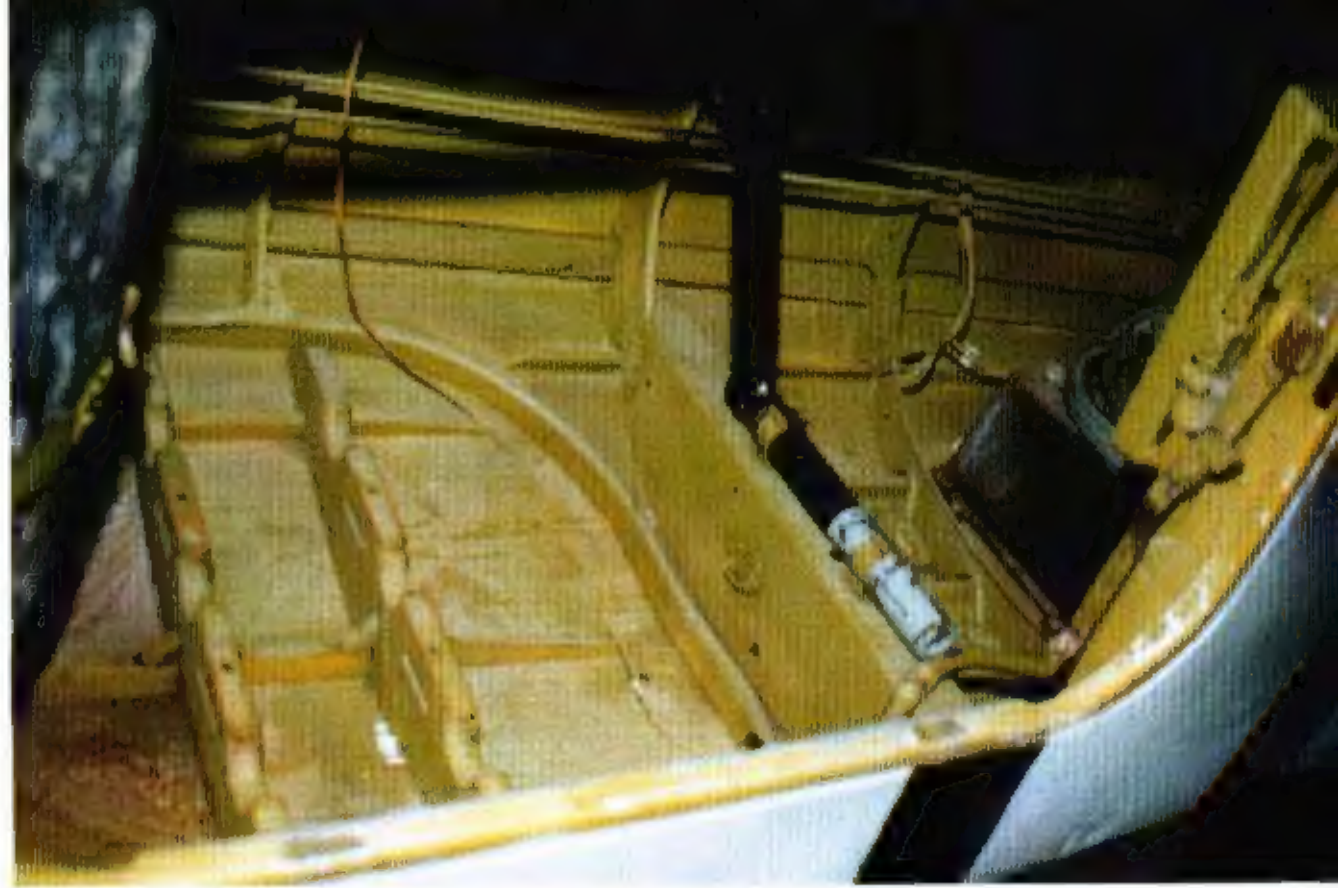
(Above) Looking forward through the aft fuselage access door at the fuselage auxiliary 115 liter (25.3 gal) fuel tank located directly behind the cockpit. This tank did not have a cockpit indicator, and the pilot considered it empty when the rear tank of the two main fuel tanks, both located below the cockpit, indicated below 240 liters. (Author: Ryle)

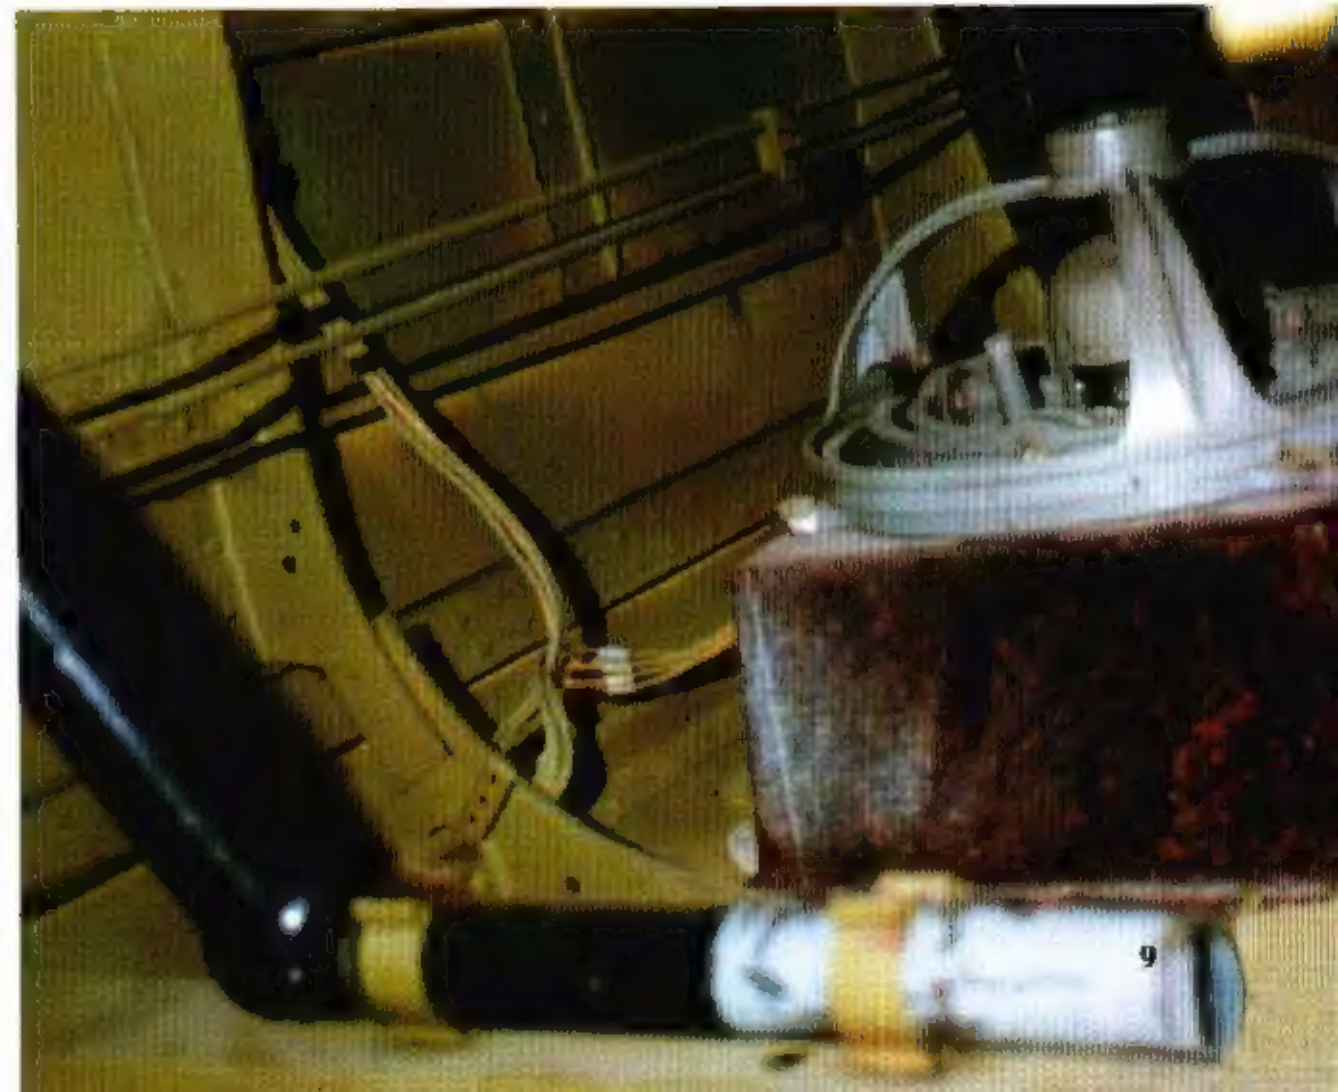
(Above right) On the floor of the fuselage is the somewhat rounded door that also provided access to the auxiliary fuel tank. To save on strategic materials late in the war this was made of wood. The engine starter crank is clipped to the lower bulkhead just in front of the remote compass. (Author: Ryle)

(Right) Inside the fuselage looking aft at the remote compass. Along the interior are vertical stiffeners that provided strength to the fuselage skinning. (Author: Ryle)

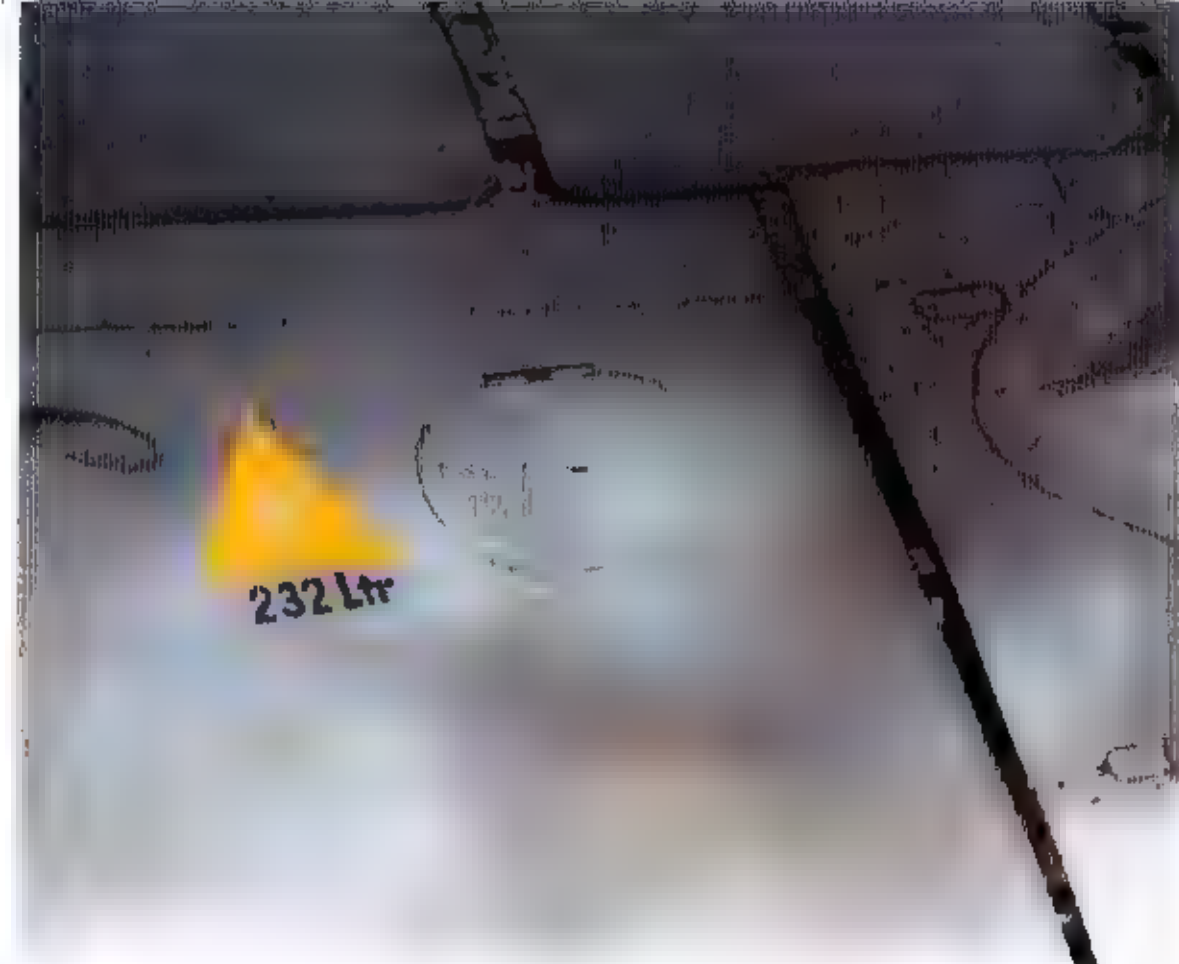
(Above) The fuel access hatch for the forward fuel tank is on the starboard side of the forward fuselage. An original fuel access hatch, it is hinged at the top. Just to the left of the yellow fuel triangle is the flare tube which extends from inside the cockpit. The rear of the supercharger intake can be seen on the right. (Author: Ryle)

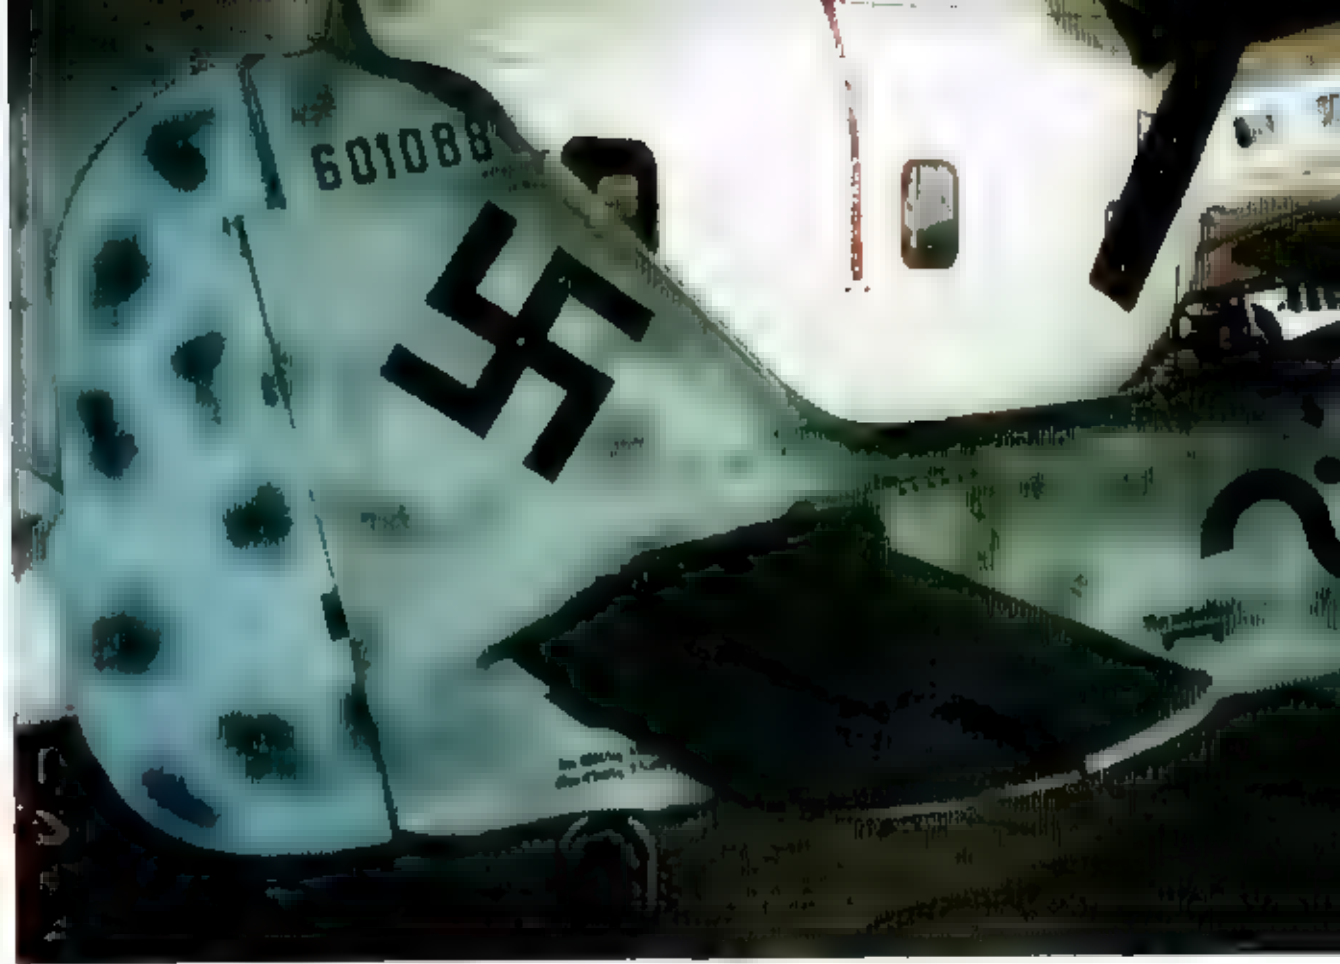
(Above) The lower starboard side of the fuselage looking aft. There are no external skin stiffeners on the tail prior to the tail wheel as are found on the later Fw 190D-13. (J. Bishop)

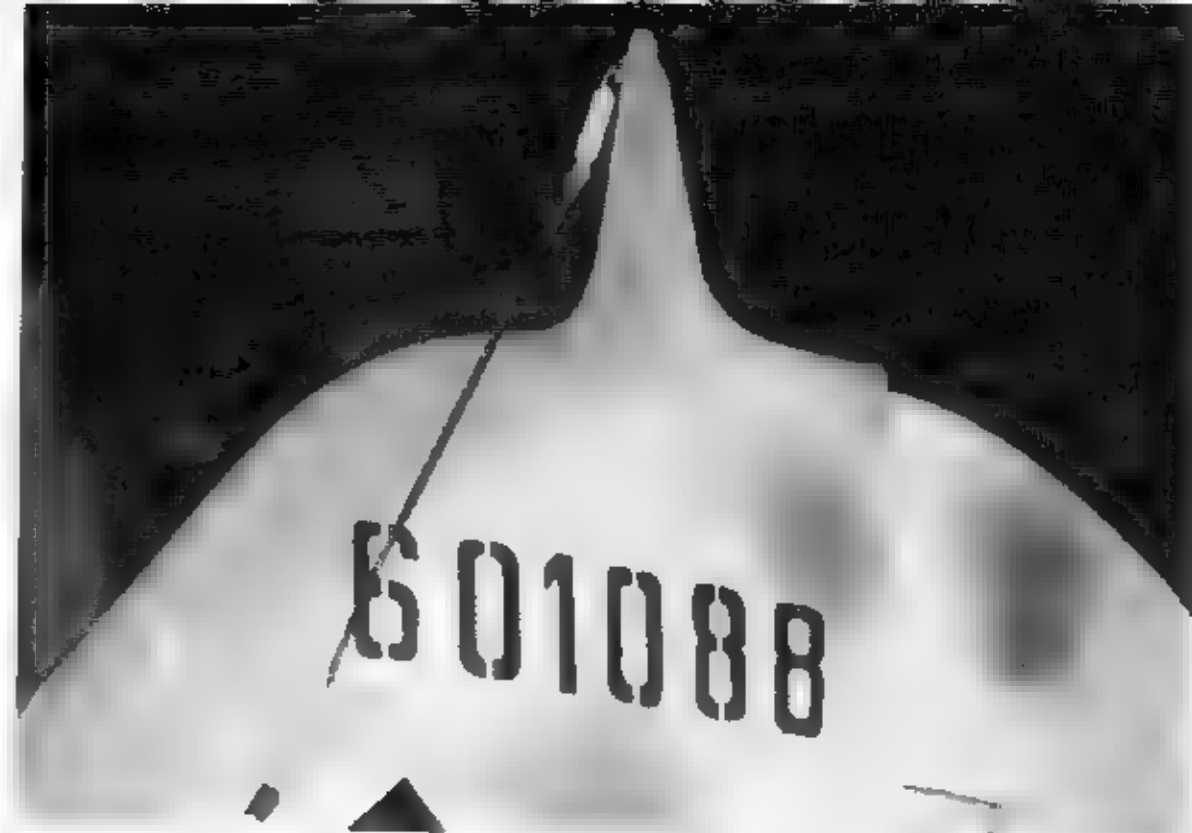
(Above and below) The rudder control rod that controls the movement of the rudder is seen on the starboard side of the aircraft. The upper rudder connection point is just aft of the Work Number. An extension to the vertical fin to provide additional lateral stability was added to the rear of the standard Fw 190A vertical fin. The panels immediately forward of the extension are not flush riveted. (Author: Ryle)

The canopy is open so the antenna wire drapes down slack. The aircraft's work number (601088) indicates it was built in a production batch of eighty aircraft that were some of the last Fw 190s to be produced before the end of the war. (Author: Ryle)

With the canopy in the closed position the antenna wire is pulled taught. The small spring is to maintain tension. (Author: Ryle)

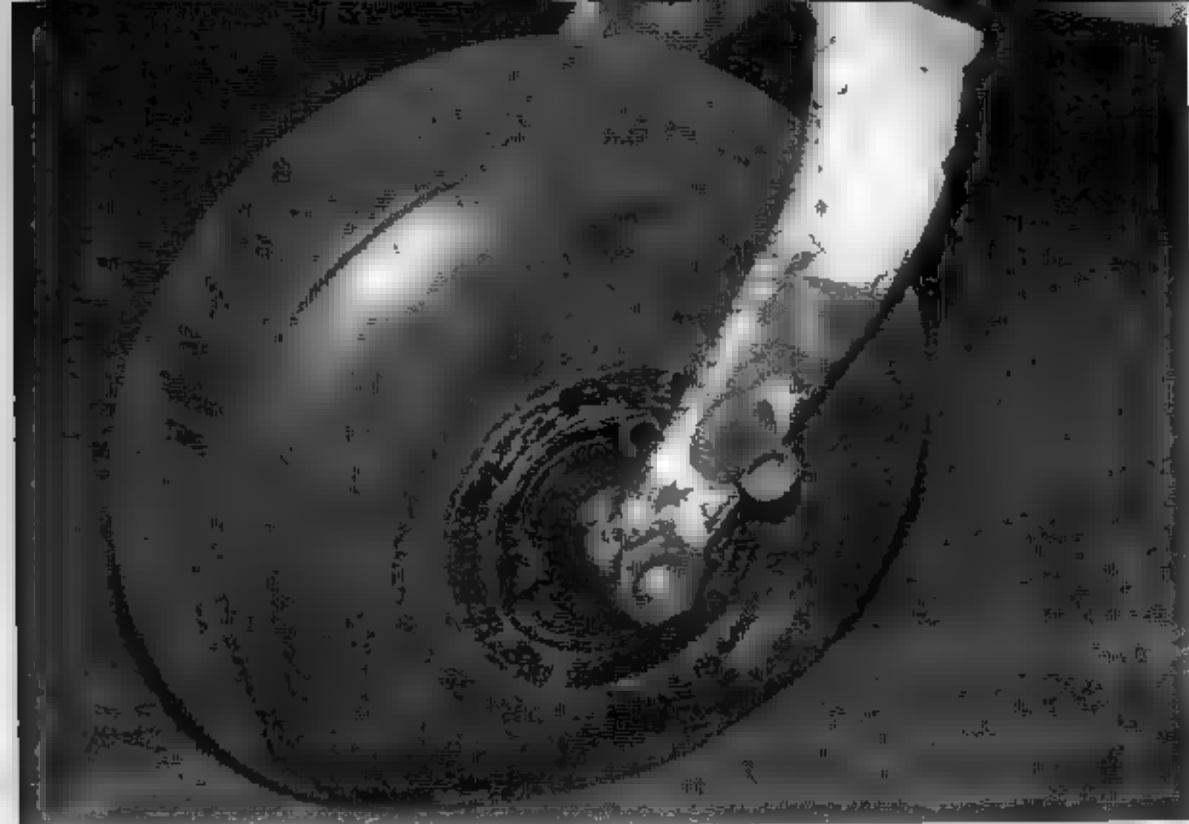
The tail wheel fork is a late war welded type with prominent rough weld lines. As the war got more desperate such things as deburring weld joints were ignored especially when they did not affect the functioning of the equipment. With no original available an American tail wheel and tire have been substituted. An unusual feature is the addition of a fairing around the tail wheel opening. (Author: Ryle)
